COMPEX-EC Flight RF02 – Polar 5 – 2025/04/06

- Evaluation of EarthCARE MSI instrument by flying parallel to the satellite track
- Passing over the Pallas research station

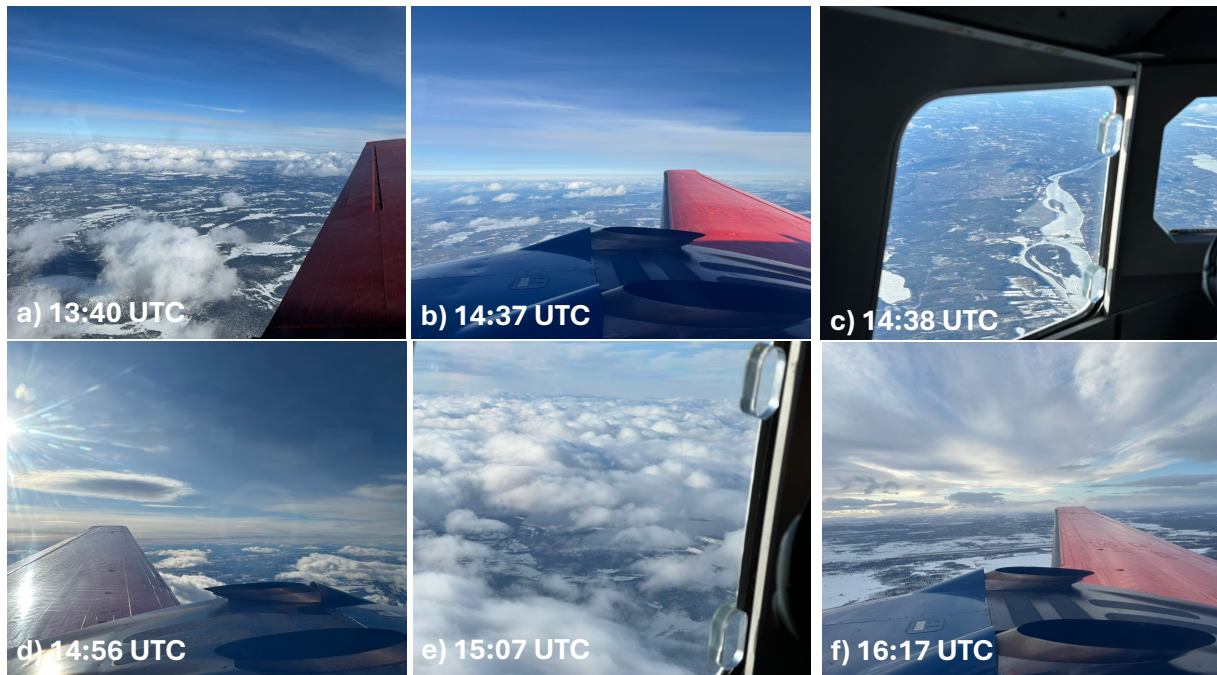
In Fig. 3 the actual cloud situation during the flight is shown. As mentioned before, the forecast was mostly right between WP1 and WP2. On the way to Pallas, the clouds were thicker than we expected.

Figure 3: Photos taken during RF02 to the right side of the plane (a,b,f) and to the left side (c, d, e).

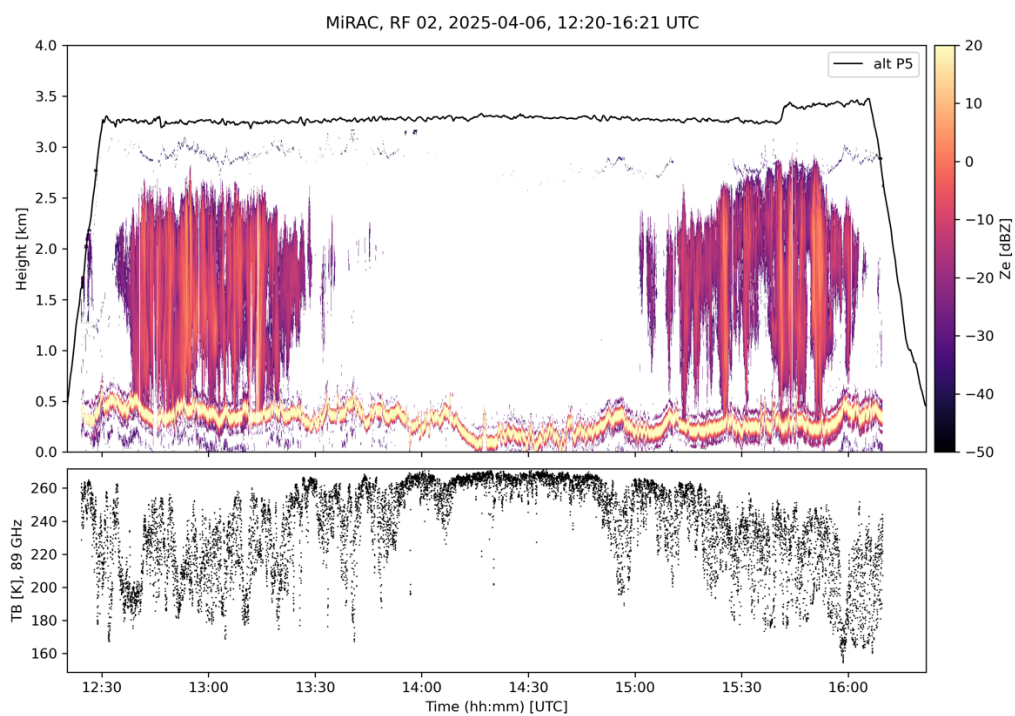
Figure 4: MiRAC radar (upper panel) and 89 GHz brightness temperature (lower panel).

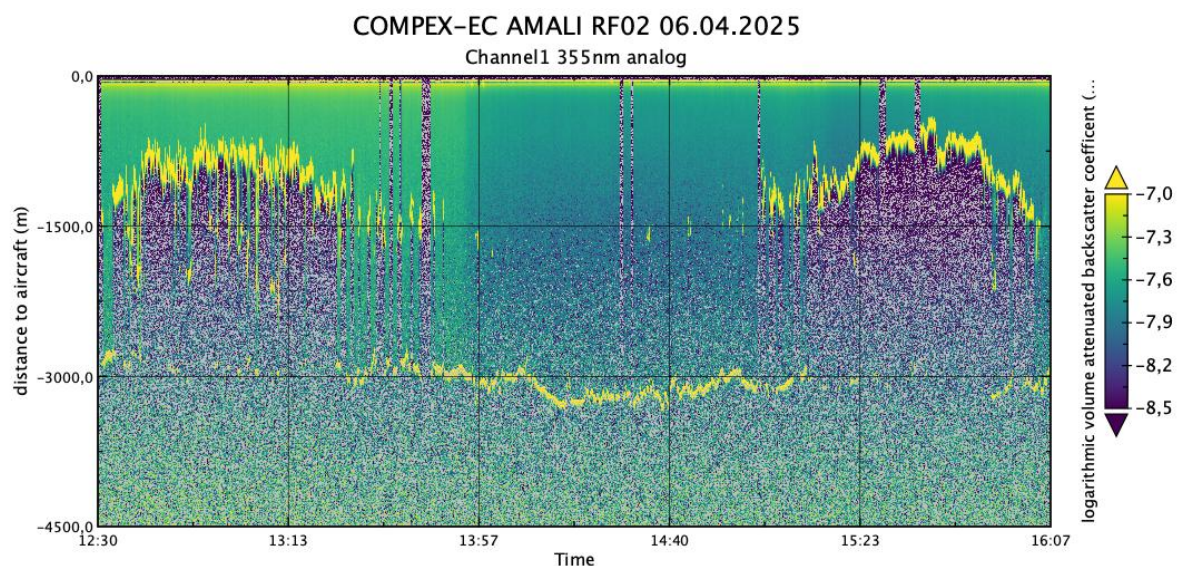
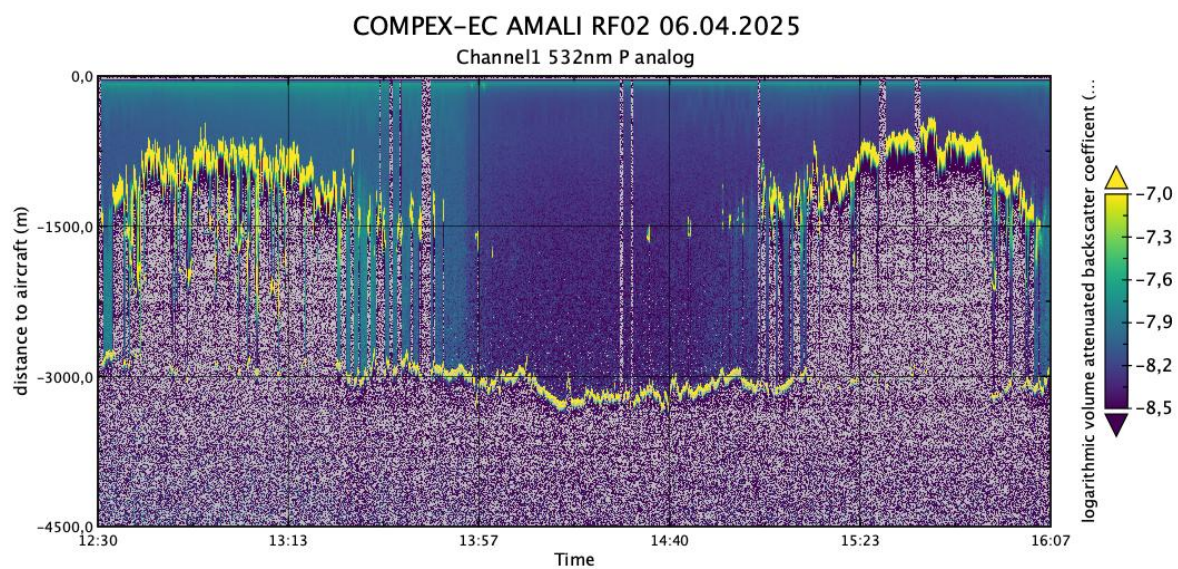
Figure 6: AMALi Lidar quicklooks. Upper panel for 355 nm and lower panel for 532 nm.

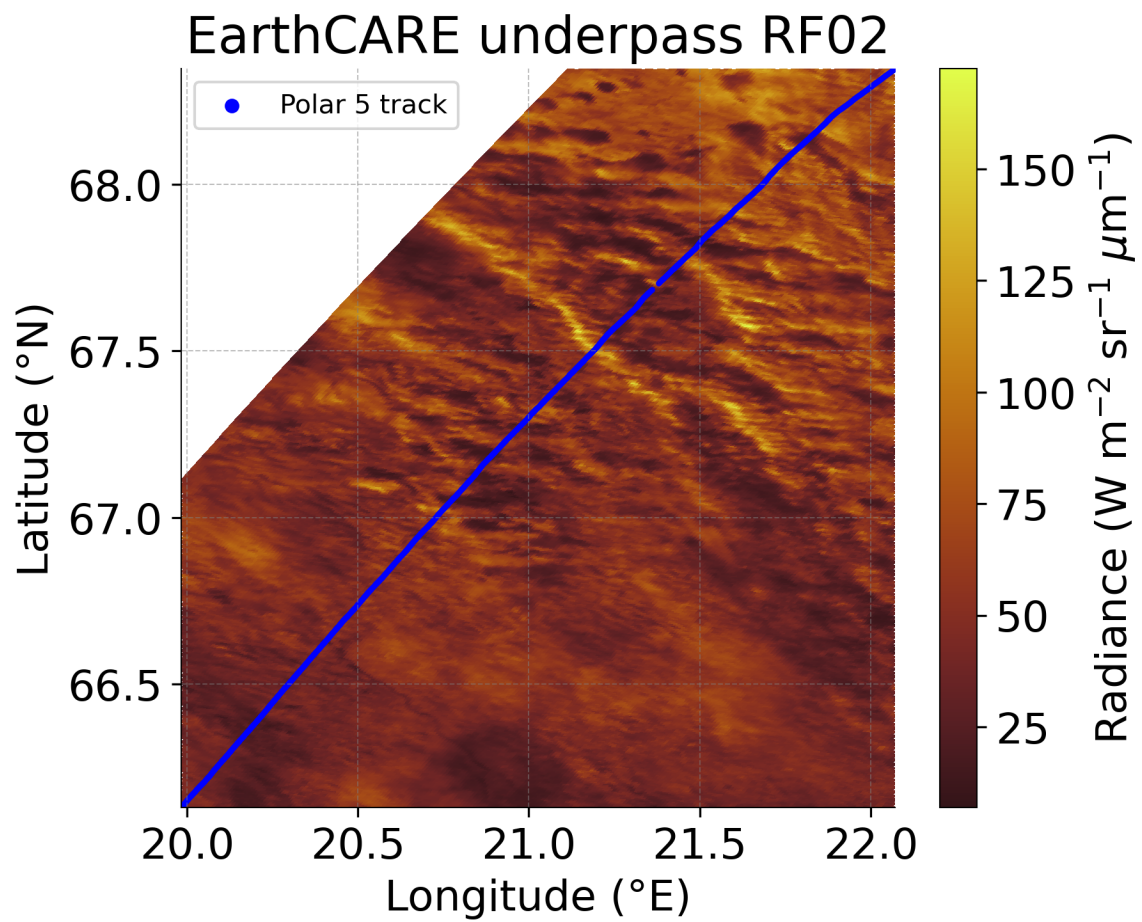
Figure 10: EarthCARE MSI data with Polar 5 flight track.

Initially, the mission was planned as an underflight of the EarthCARE satellite between WP1 and WP2. However, a misalignment between the Polar 5 flight path and the EarthCARE orbit (32 km off) led to an unexpected, yet beneficial, outcome: two parallel flight legs, ideal for comparing MSI data with our spectral imaging instruments, namely EAGLE and HAWK.
