COMPEX-EC Flight RF03 – Polar 5 – 2025/04/07

Objectives: EarthCARE underflight - MSI leg

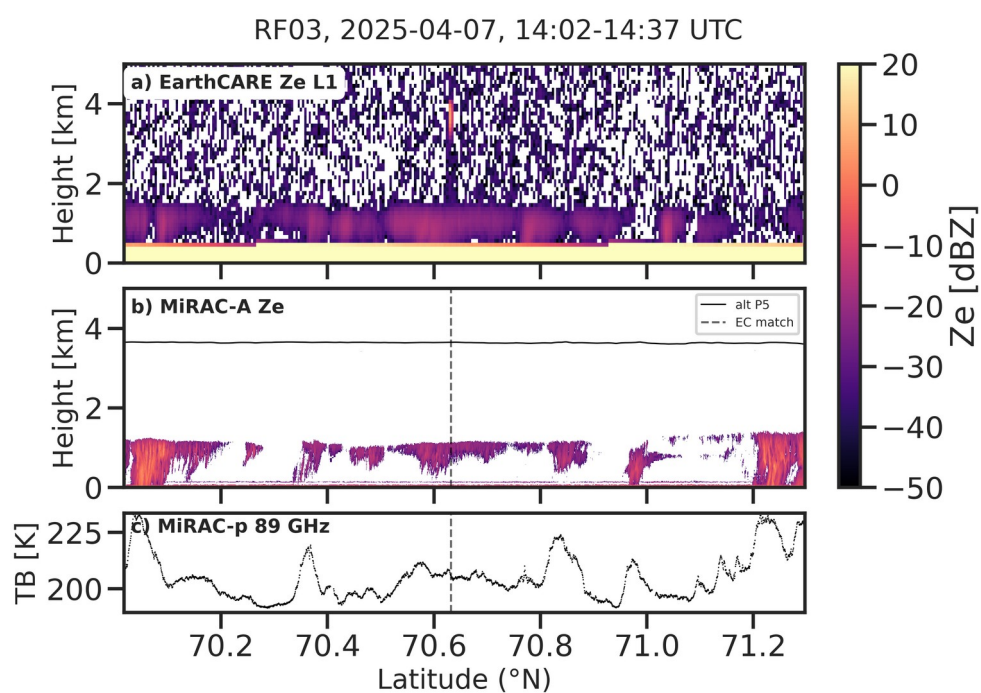
Comparison between EarthCARE Ze and MiRAC-A Ze together with the passive channel at 89 GHz for the direct overpass section.

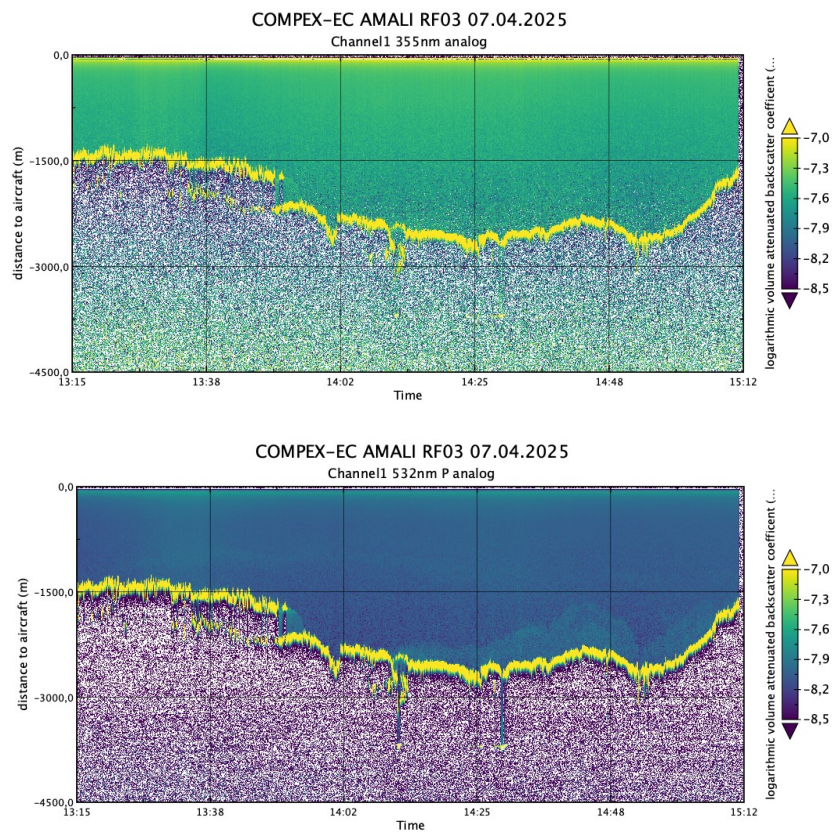
355 nm (top) and 532 nm parallel (bottom) analog for the whole flight.

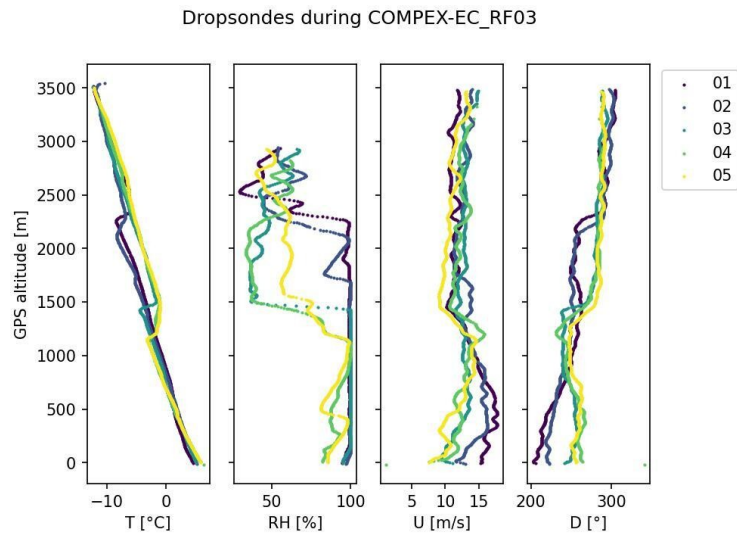
Dropsonde profiles from the flight.

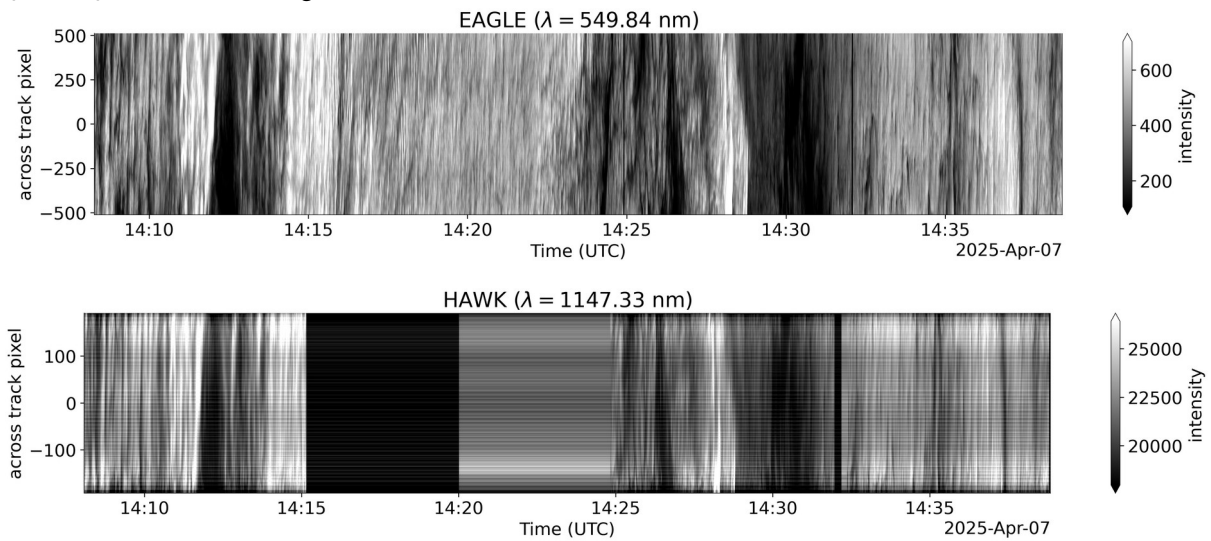
EAGLE VIS (top) and HAWK NIR (bottom) for the whole flight.
