COMPEX-EC Flight RF07 – Polar 5 – 2025/04/15

Figure 1: Flight and satellite track over MODIS RGB composite satellite image for RF07 on 15.04.2025.

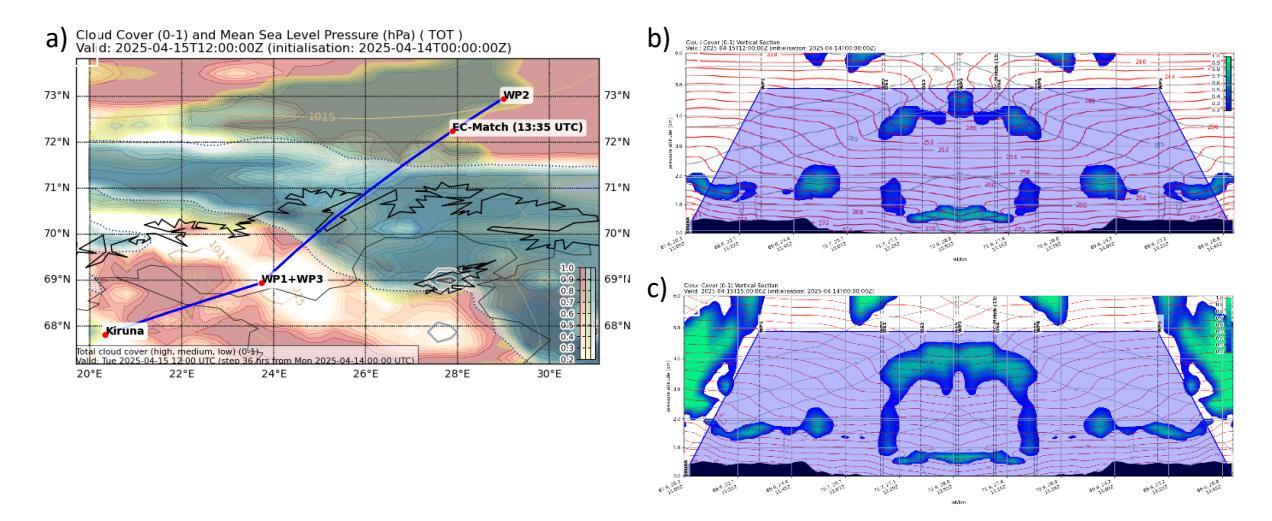
Figure 2: Forecasted cloud conditions from ECMWF in the area of the planned flight track (a). Vertical cross sections of the ECMWF cloud forecast along the flight track for 12:00 UTC (b) and 15:00 UTC (c).

On April 15, two low-pressure systems were situated southwest and northeast of Kiruna. Warm air was advected from the south toward Kiruna along a warm front. However, for this flight, the latter (northeastern) low-pressure system played a more significant role, as cold air prevailed over the ocean region we were flying in. Low-level clouds were forecast along our flight path, with higher clouds reaching up to 4.5 km. We noticed that, overall, the models underestimated the amount of low-level cloud cover and overestimated the thickness of the higher clouds. Especially towards waypoint 2 (WP2), we observed more low-level clouds, likely associated with a weak cold air outbreak induced by the northward flow around the low-pressure system. In addition, we encountered convective clouds reaching heights of up to 4.5 km that were precipitating but not captured by the models. These clouds were associated with a small-scale disturbance moving southward as we approached the northern Norwegian coast. On our way back to Kiruna, we observed more high-level clouds, some even exceeding 5 km in altitude. These were linked to the warm front of the southern low-pressure system and were correctly forecast by ECMWF. Overall the models correctly forecasted the appearance of clouds along our flight path, also the low-level clouds over the ocean, but slightly overestimated the higher cloud cover and slightly underestimated the low-level clouds.

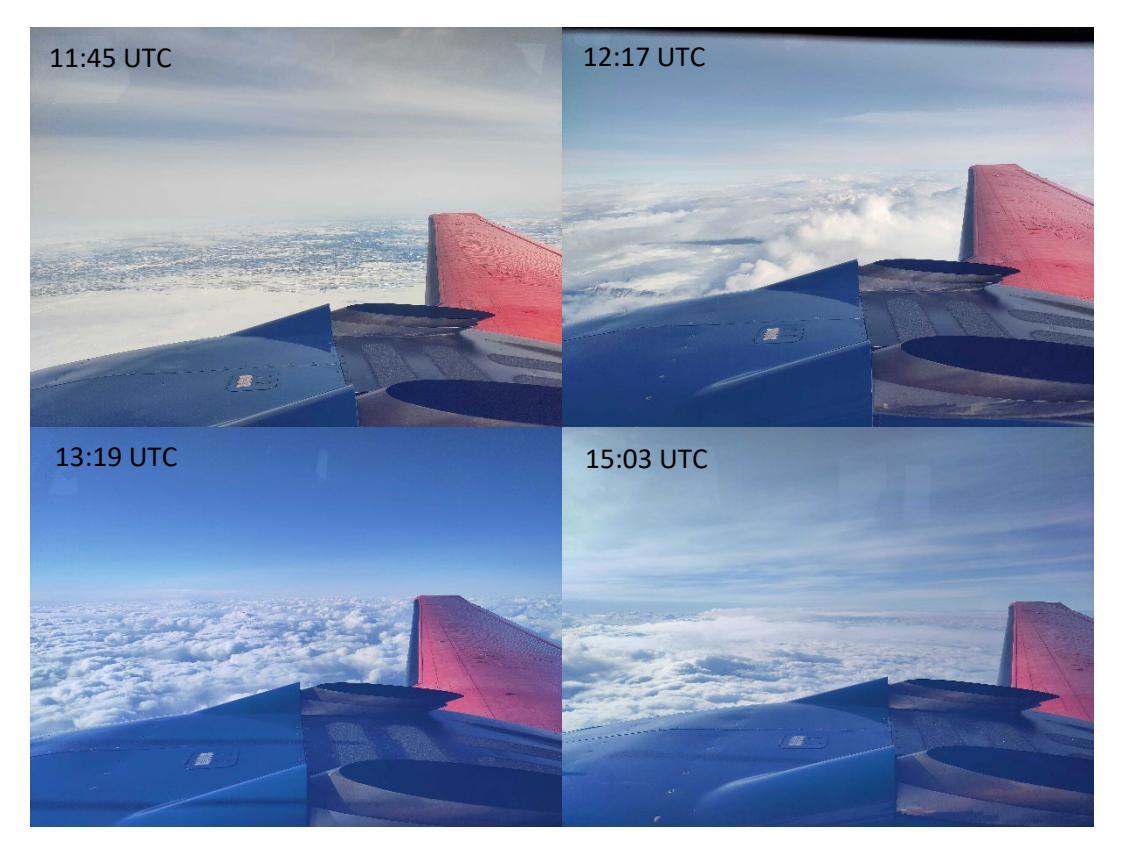
Figure 3 shows the cloud development during the flight. Over land, there were more low-level clouds and fewer cirrus clouds towards the sea, so that over the sea, including at the time of the satellite overpass, there was a dense cloud cover below us and clear skies above us. The cirrus clouds reappeared on the return flight over land, so the spontaneous idea of flying a radiation square at WP3 was abandoned. The low-level cloud cover over land expanded during the afternoon, so we had to cross it for landing.

Figure 3: Photos taken during RF07 to the right side of the plane.

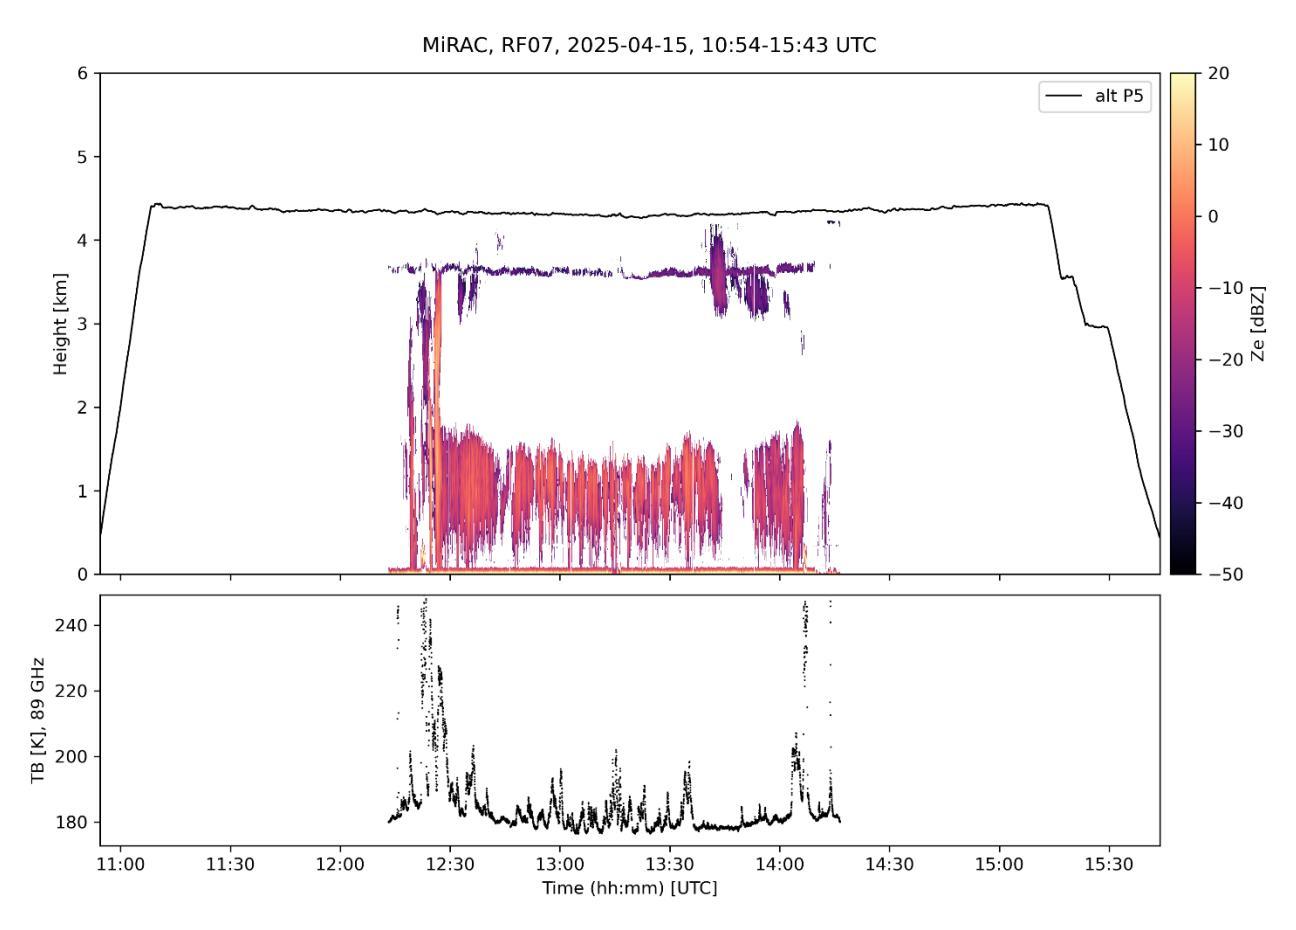
Figure 4: MiRAC radar (upper panel) and 89 GHz brightness temperature (lower panel).

- Five dropsondes were launched between WP1/WP3 and WP2
- HATPRO receiver 1 stability value was 0.5, so measurements had to be started 10 minutes later, when the value decreased to below 0.05 K. Should cause no issues in the data.
- Flying through some single clouds before 14:00 UTC causing the stronger signals in radar data at 4 km and no signal for low-level clouds below.

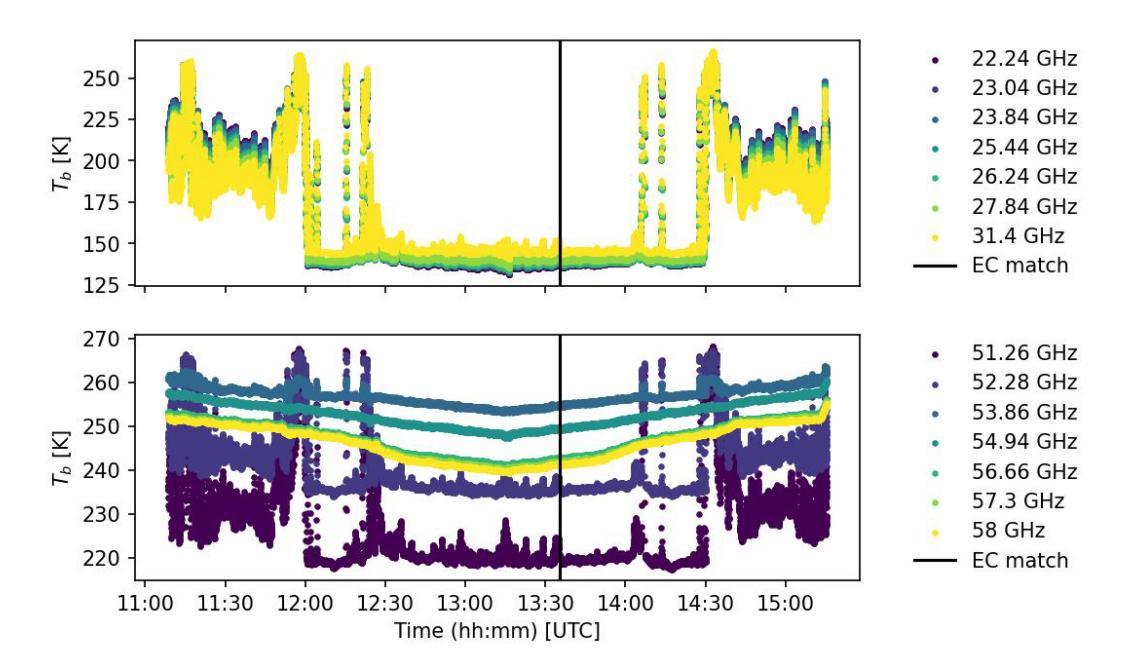
Figure 5: HATPRO brightness temperatures for different channels along the whole flight.

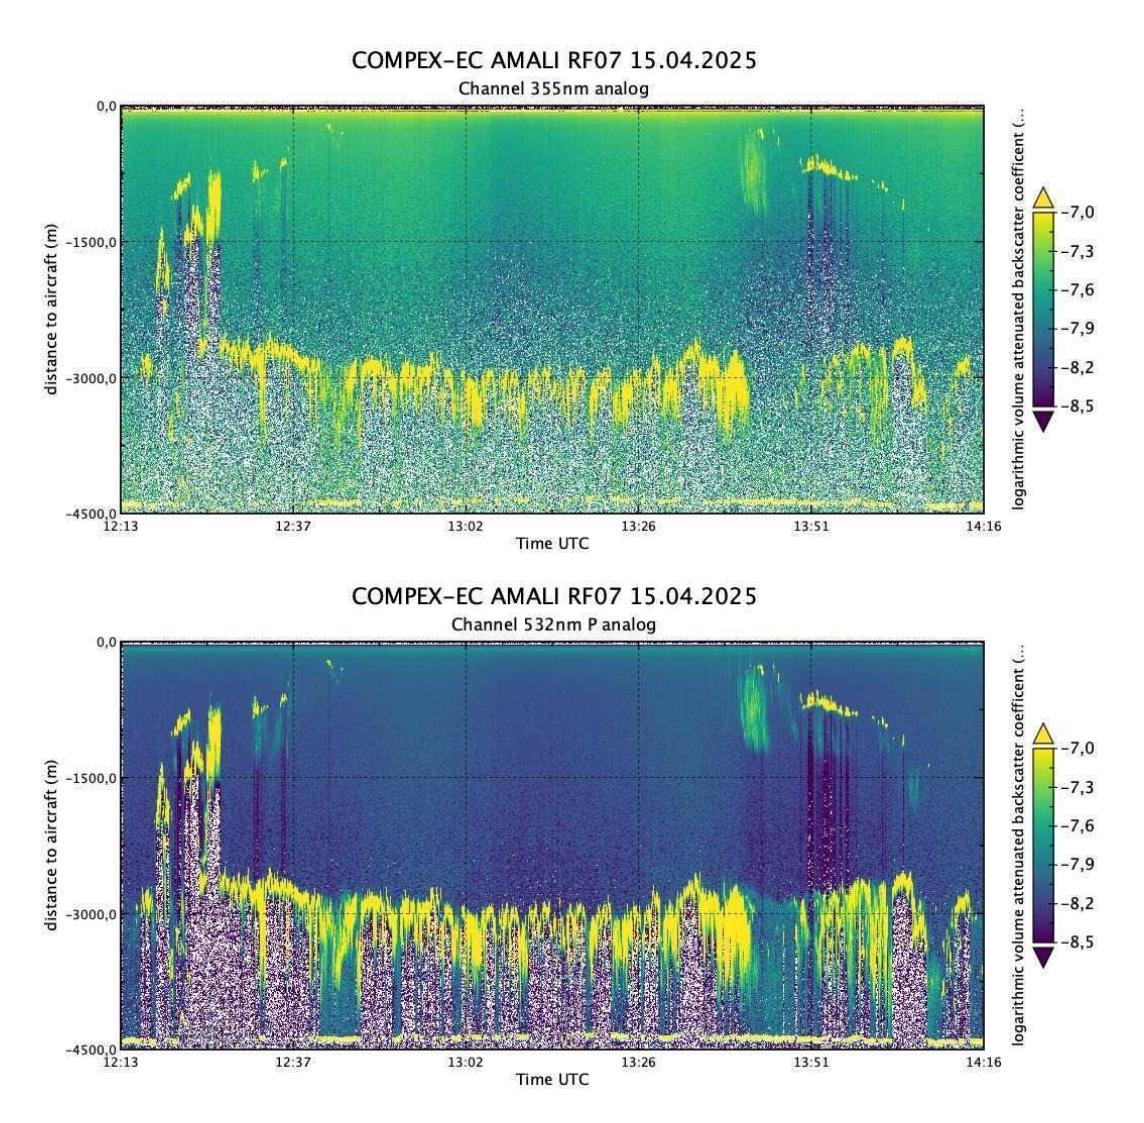
Figure 6: AMALi Lidar quicklooks. Upper panel for 355 nm and lower panel for 532 nm.

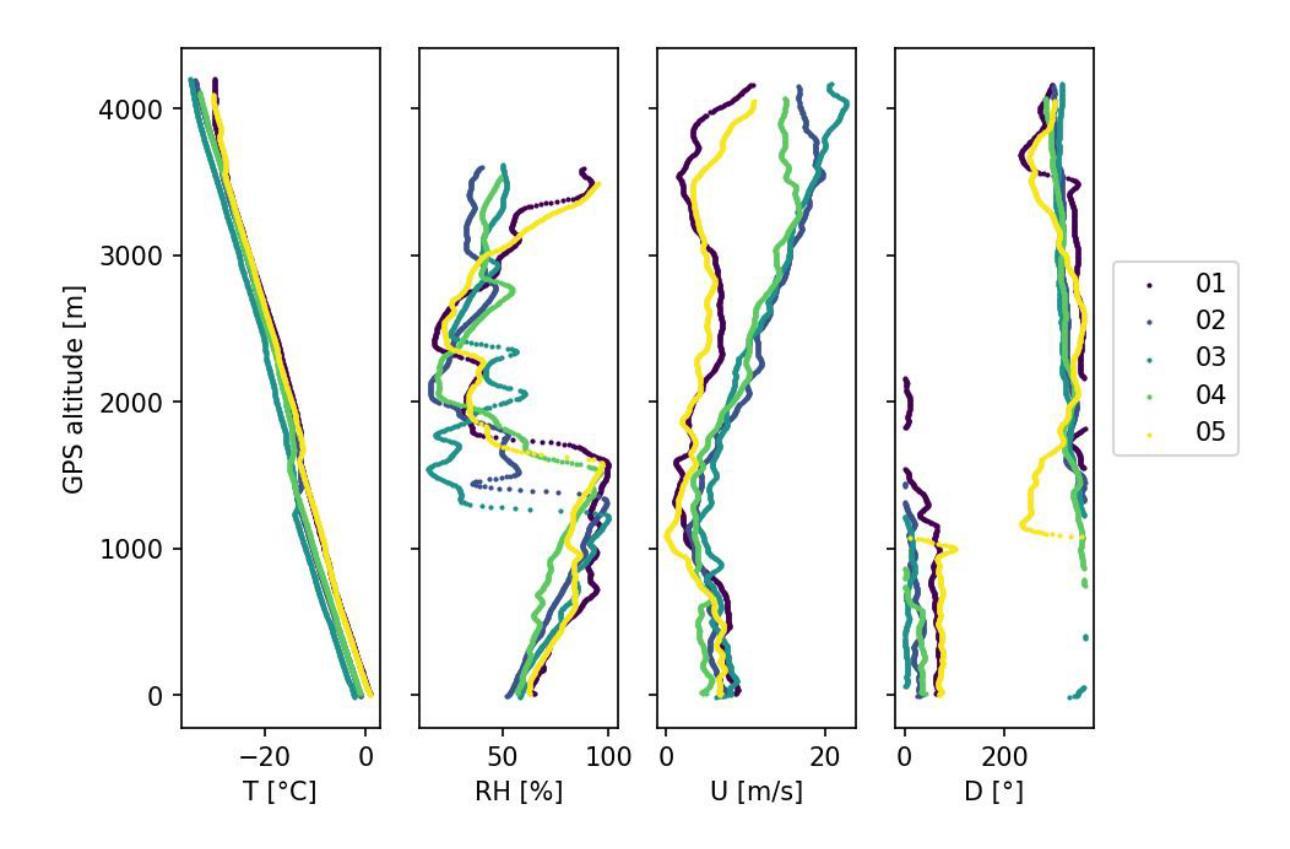
Figure 7: Vertical profiles of all launched dropsondes.

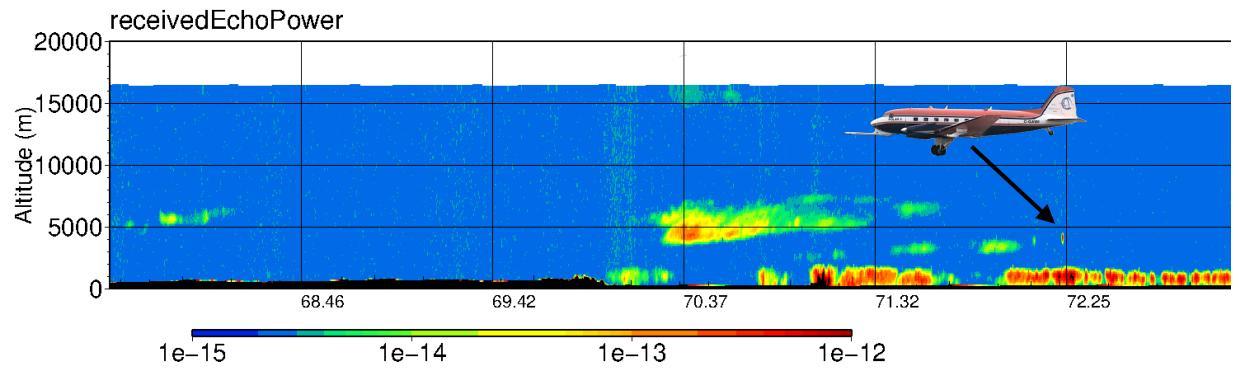
Figure 8: Quicklook from the EarthCARE radar. The Polar 5 is visible as an echo in the EarthCARE radar data.

Between WP2 and WP3, the EarthCARE satellite overflowed us as planned at 15:35 UTC. The corresponding signal from Polar 5 can also be seen in the EarthCARE radar data in Figure 8. After reaching WP3, we returned to Kiruna.

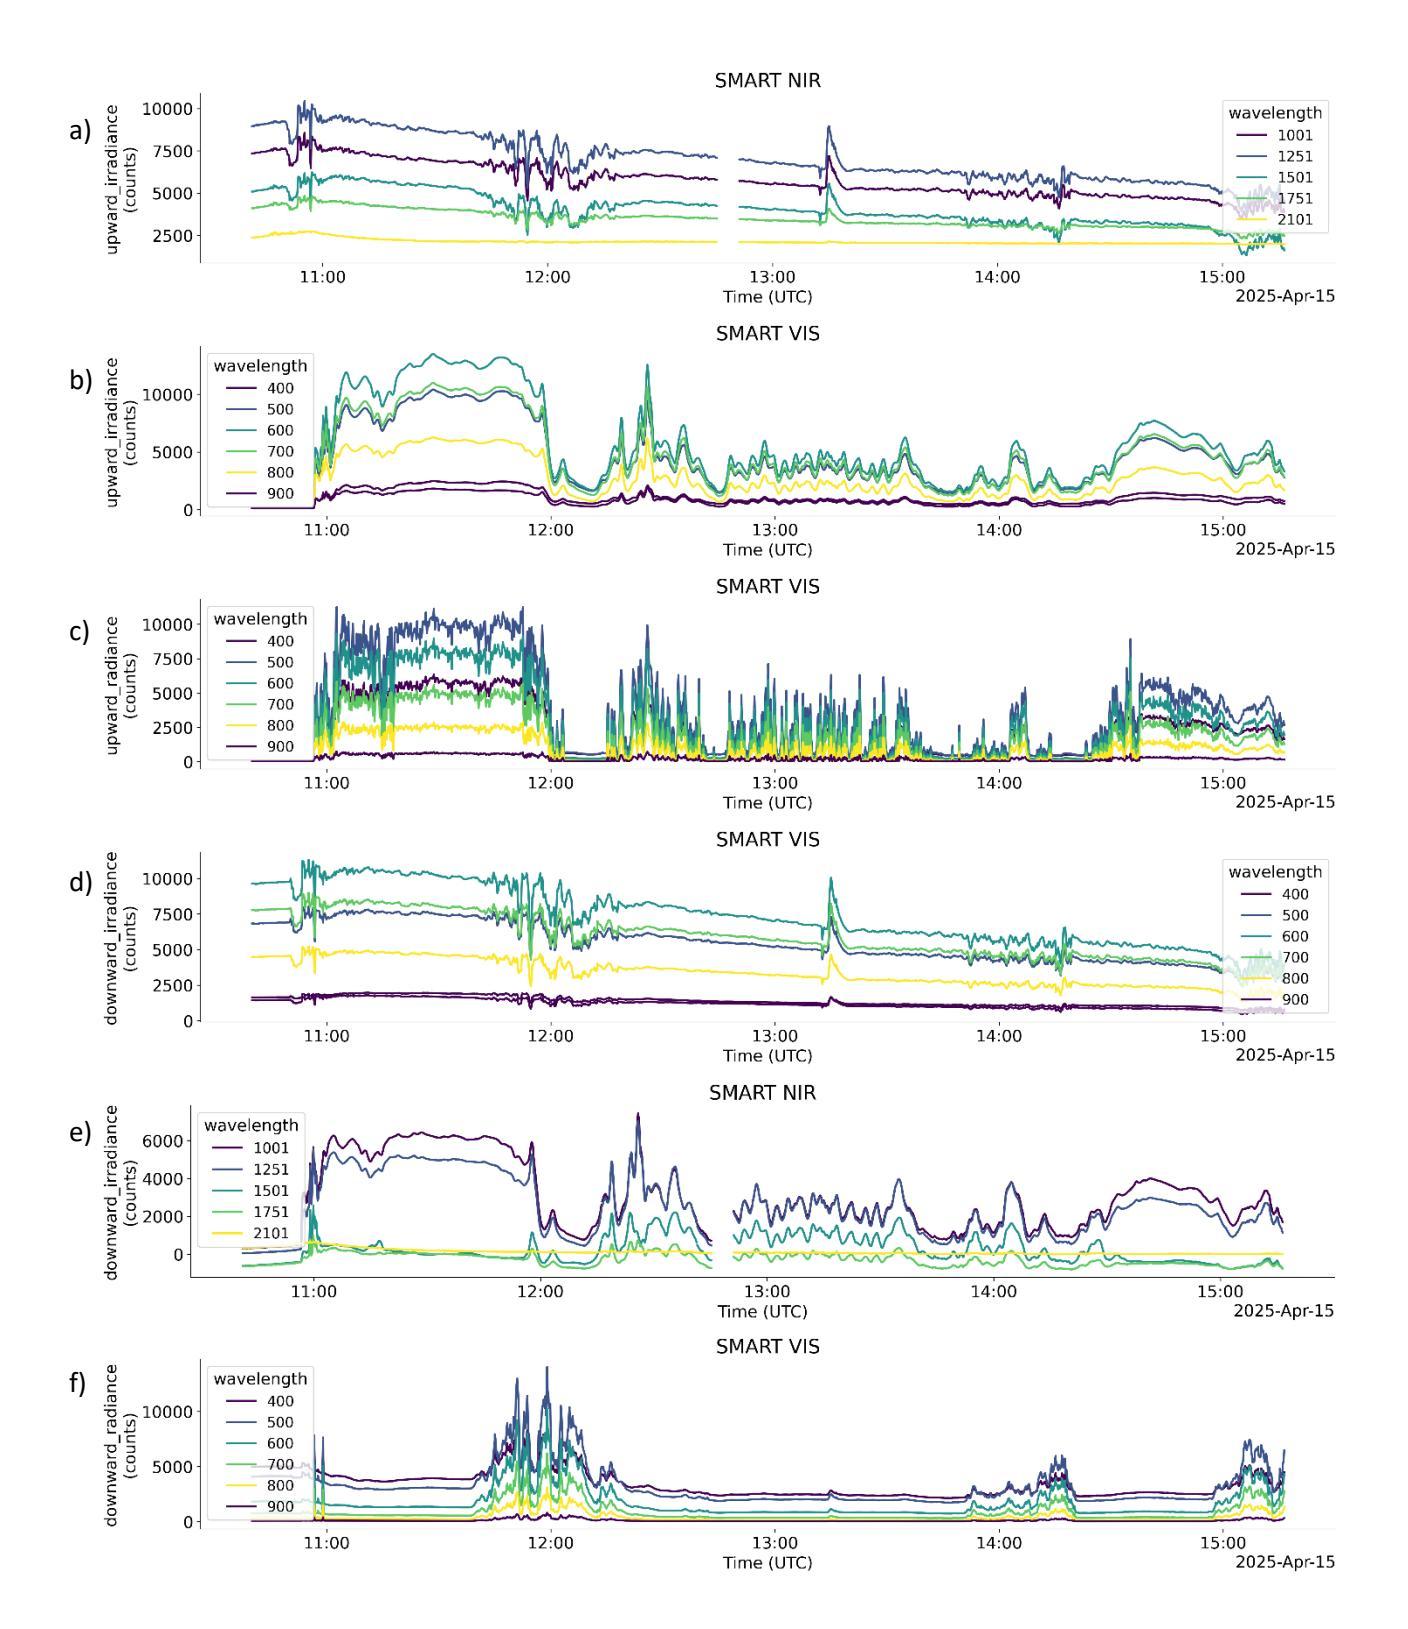
Figure 9: SMART quicklooks of the upward and downward irradiances and radiances.
